Manhole Inspection Summary

Manhole # S25UU1001MH

Insp Date: **5/3/07 5:10 PM**

Location Address: **303 CLUB RD**

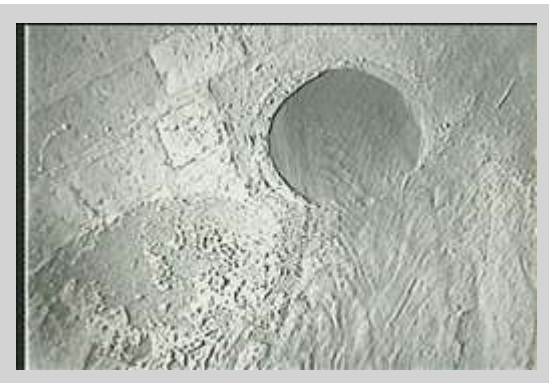
6 in. Circular Gravity Sewer Pipe In @ 3 O'Clock

Rod and Bar (Angled)

Pipe Material: **Clay** ☐ Pipe Lined

Infiltration: **None** Pipe Seal Cond: **Unknown**
